ATTACHMENT I
DYNAMIC STABILITY STUDY RESULTS
ALTERNATIVE AC 1, PEAK CONDITIONS

ALTERNATIVE AC-1

Second Paloverde-Devers 500 kV line (Harquahala-Devers),
 Ramona 500 kV Substation, Imperial Valley-Ramona 500 kV line
 Reactive Support (added for dynamic stability in bold font):

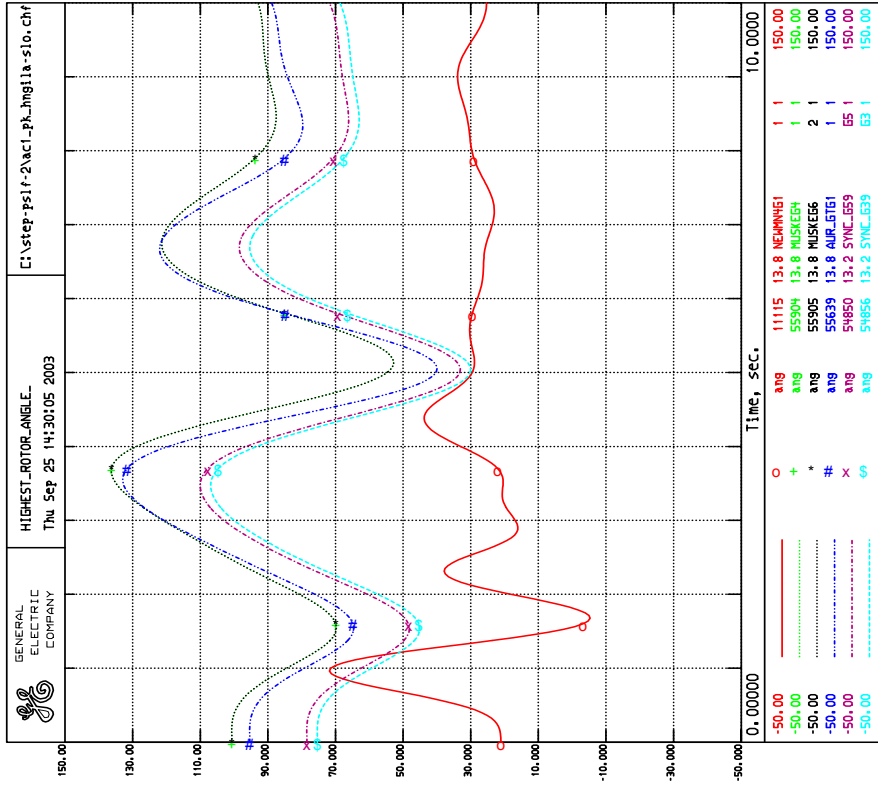
2007 HEAVY SUMMER PEAK CASE
 STEP STUDY WORK - DETAILED STUDIES ALTERNATIVE AC-1:
 HARDWALLA-DEVERS AND IMPERIAL VALLEY-RANOMA 500 KV LINES
 SECOND 500/230 KV BANK AT FIGUEL AND DEVERS
 UPGRADE OF THERMAL CAPACITY ON SERIES CAPACITORS ON SMLP NOT MODELED

Additional voltage support: 400 MVAR STATCON ON DEVERS 500 KV
 200 MVAR SVC ON VALLEY 500 KV 300 MVAR STATCON on Devers 115 kV
 100 MVAR SVC on Wiltmonhr 161 kV
